Subject: *OIG Final Report Review of the Dade County Courthouse and the 40/50 Year Recertification Requirement, Ref. IG15-06*

*OIG Review of the Dade County Courthouse  
and the 40/50 Year Recertification Requirement*

IG15-06

February 29, 2016

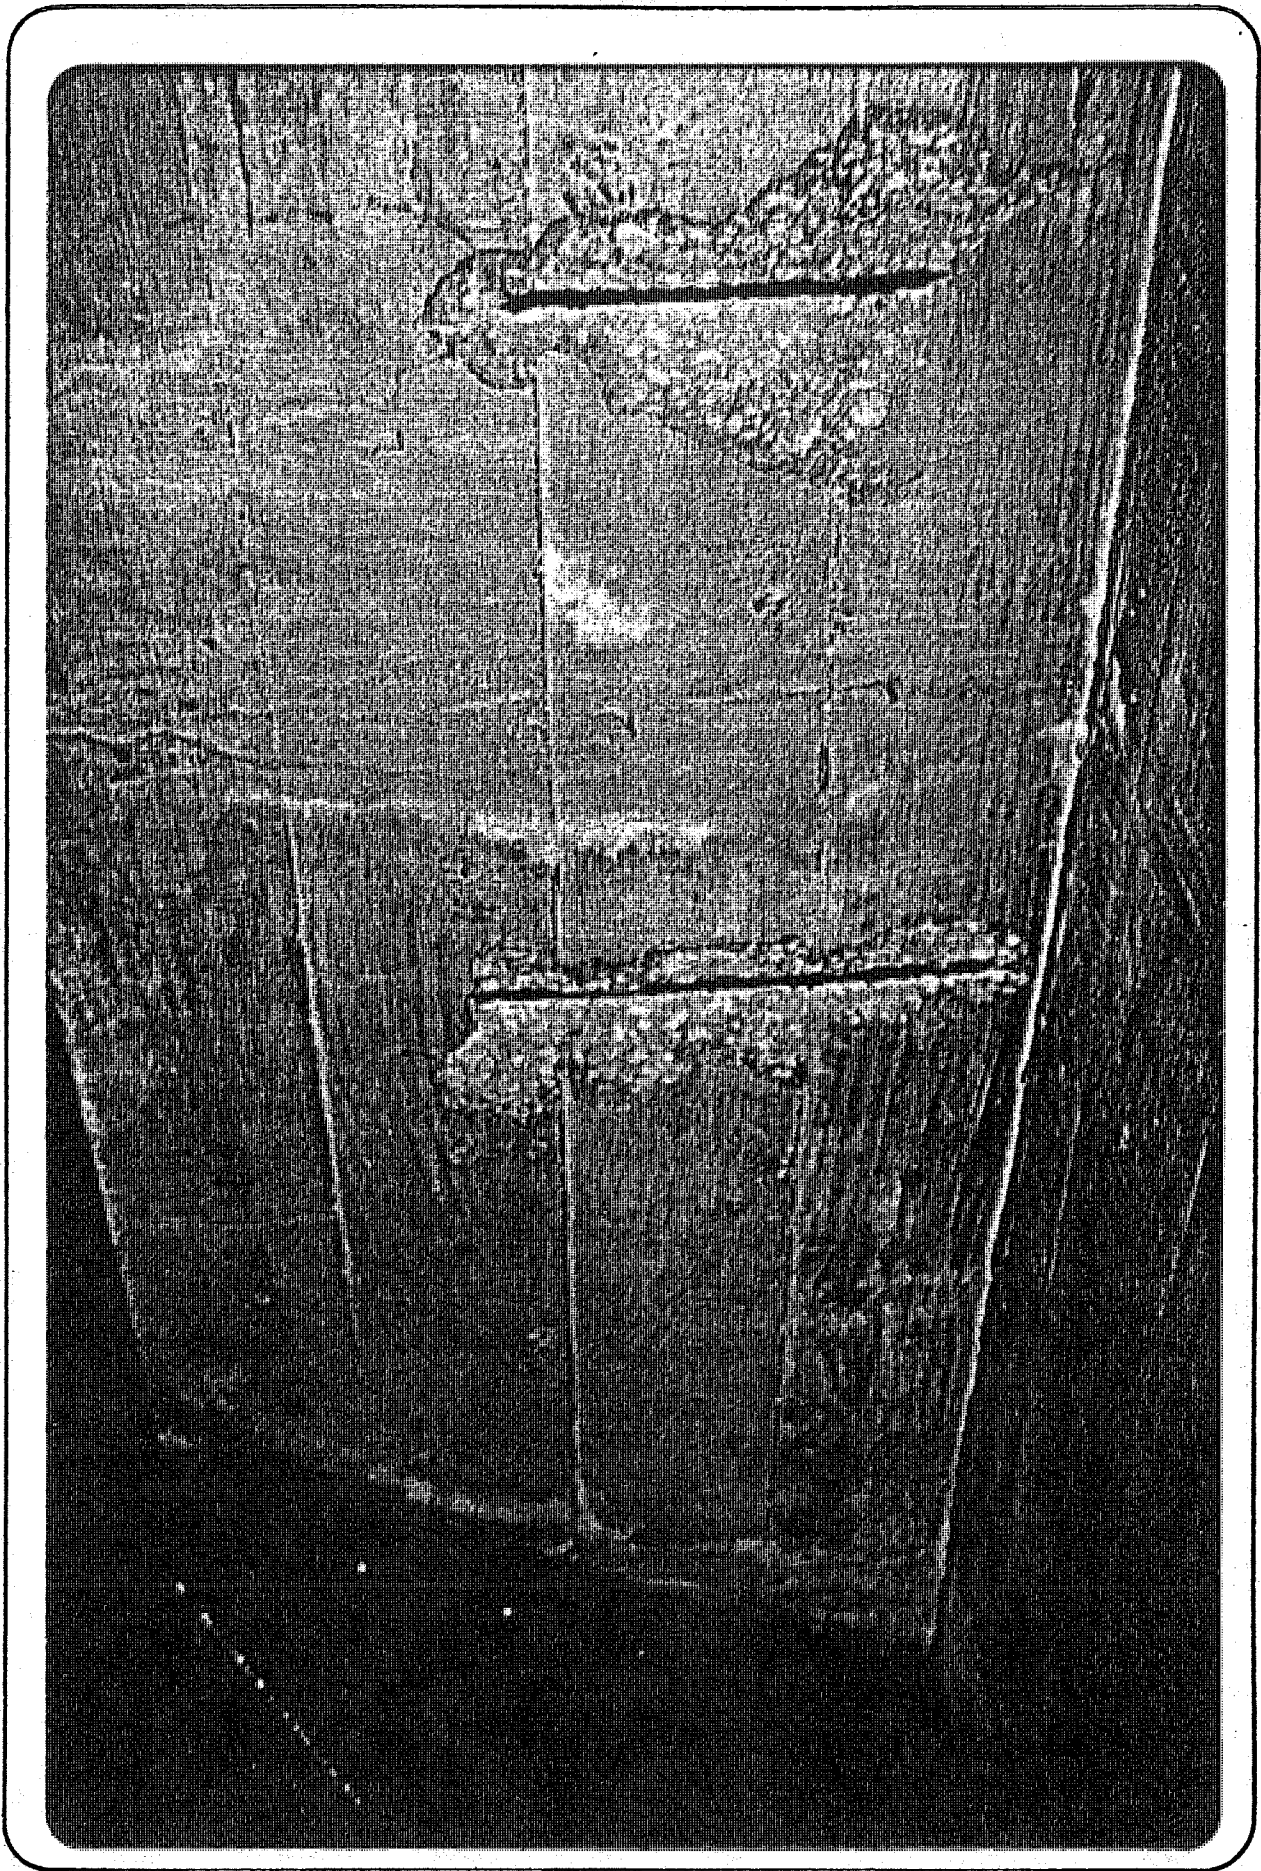
SPALLED CONCRETE AT PYRAMID

The steel frame work in the pyramid area will be closely examined and cleaned after roofing repairs eliminate present leaks. All rusting will be cleaned. Loosened concrete adjacent to the frames will be chipped away. Defects, if any, will be repaired and the entire frame will be treated and coated with a rust inhibiting paint system.

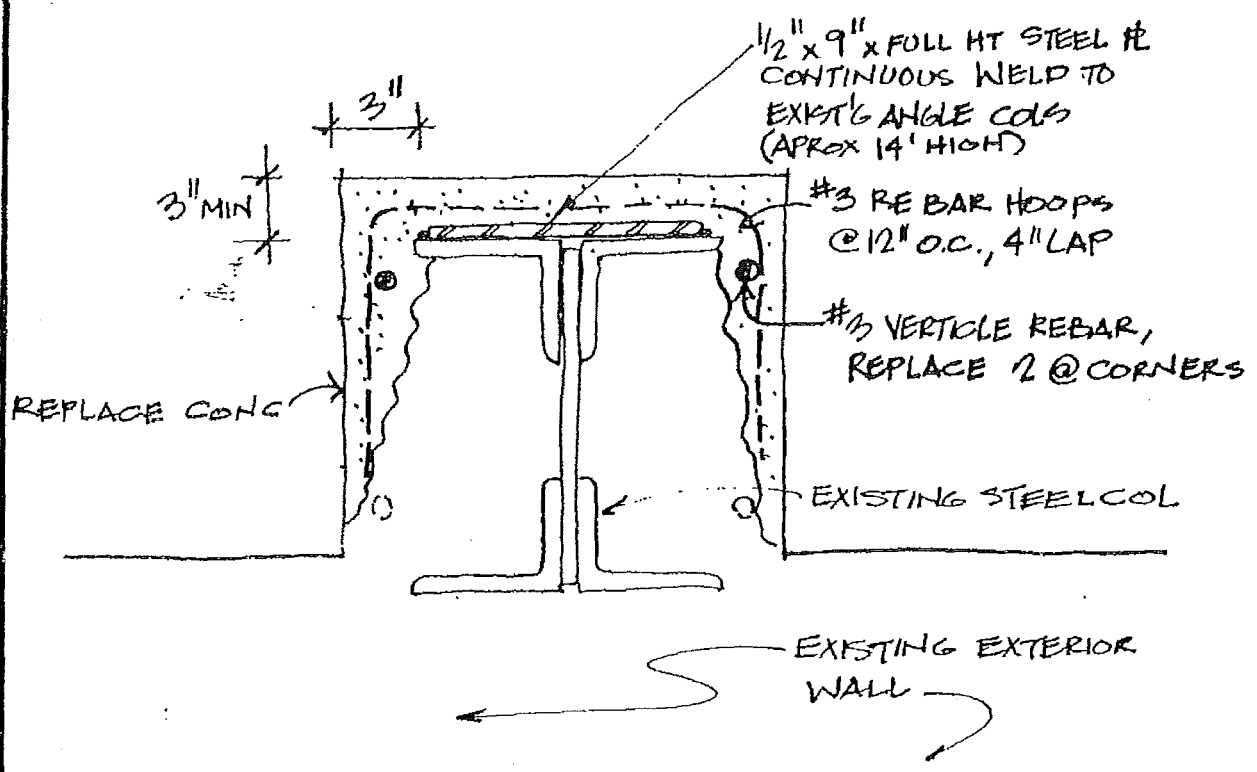
### Repair to Cds. A-2, A-3, A-4, A-5, A-6

The basement columns were re-examined in December 1987 after the remedial work had begun and after the columns were more exposed. Additional remediation work to include welding plates to the full height of the column angles was recommended by the structural engineer, and two drawings were prepared detailing the proposed repair work. (Exhibit 10) Mr. Piersol recalls that the repairs were performed shortly thereafter. As previously mentioned, M.C. Harry was on-site when the County approached the firm to do the “40 year certification.” M.C. Harry continued renovation work on the Courthouse for several more years after the second set of inspections were
